**Town of Brookline  
Massachusetts**

# **Walnut Street Traffic Calming Evaluation**

October 2003

**BETA Group, Inc.**

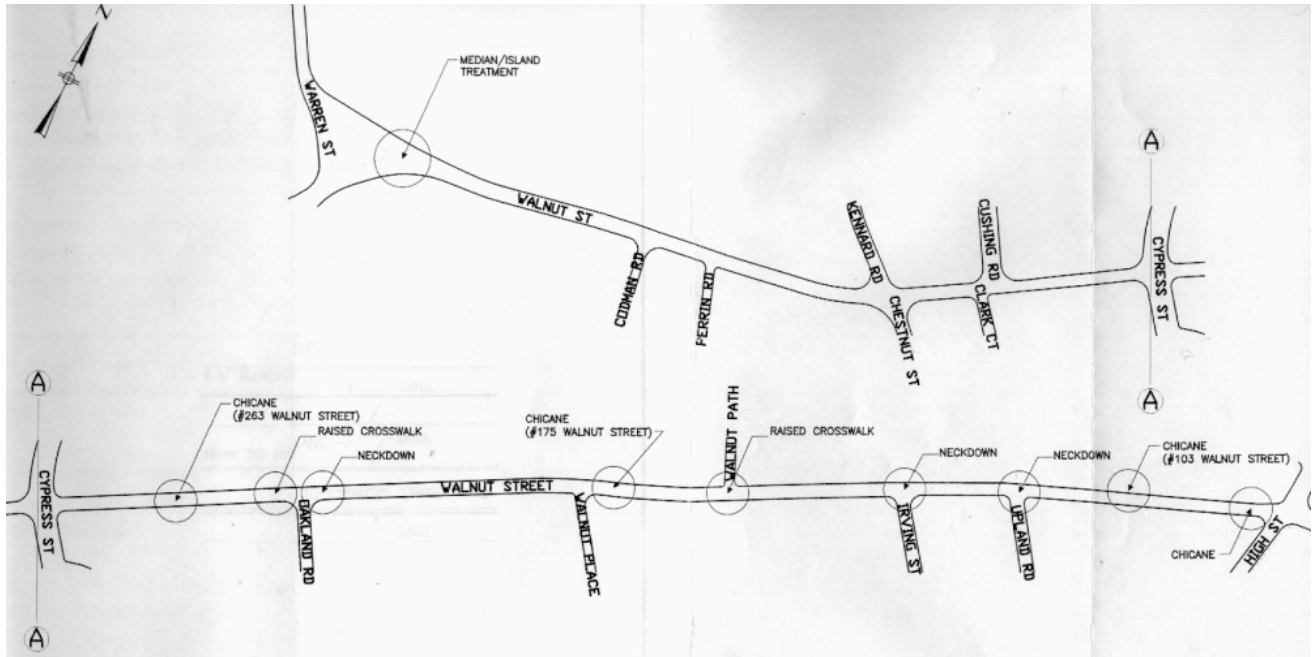
Locations of the existing traffic calming measures on Walnut Street are shown in Figure 1 and listed as follows:

- Neckdowns – located at Upland Road, Irving Street, Walnut Path and Oakland Road
- Raised Crosswalks – located at Walnut Path and Oakland Road
- Chicanes – located at High Street, #103 Walnut Street, #175 Walnut Street and #263 Walnut Street.

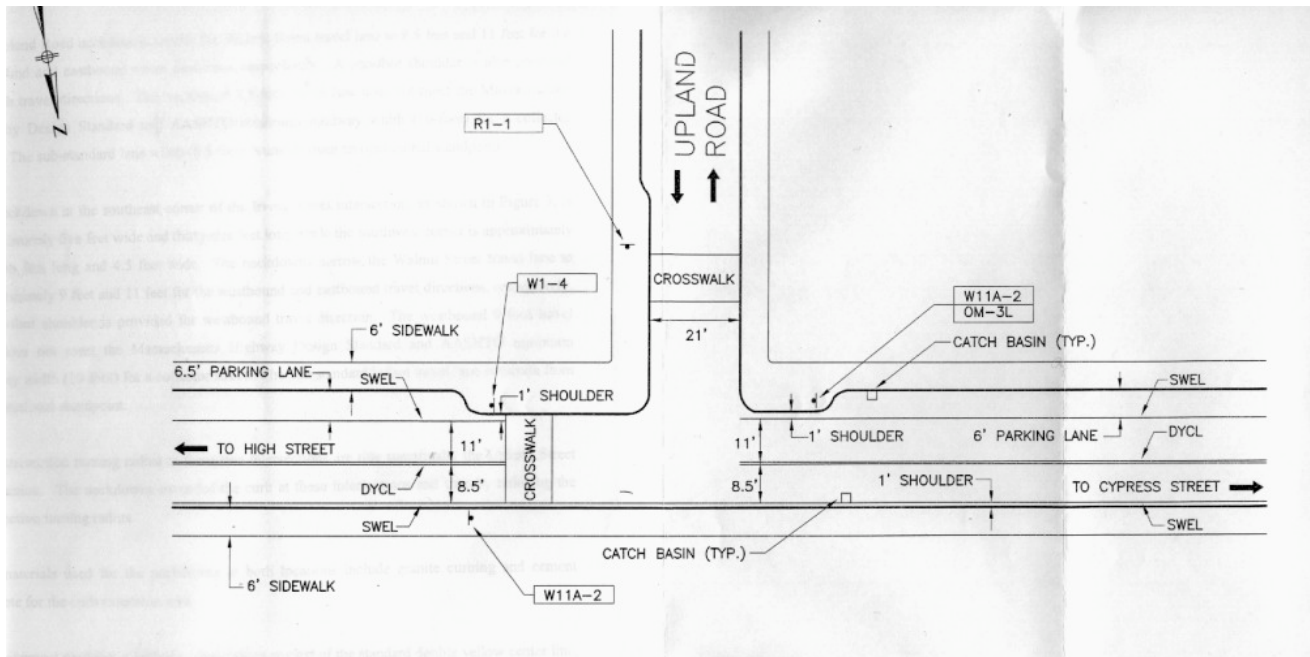
The Upland Road neckdowns narrow the Walnut Street travel lane to 8.5 feet and 11 feet for the westbound and eastbound travel directions, respectively. A one-foot shoulder is also provided for both travel directions. The westbound 8.5-foot travel lane does not meet the Massachusetts Highway Design Standard and AASHTO minimum roadway width (10-foot) for a collector street. The sub-standard lane width (8.5 feet) is unsafe from an operational standpoint.

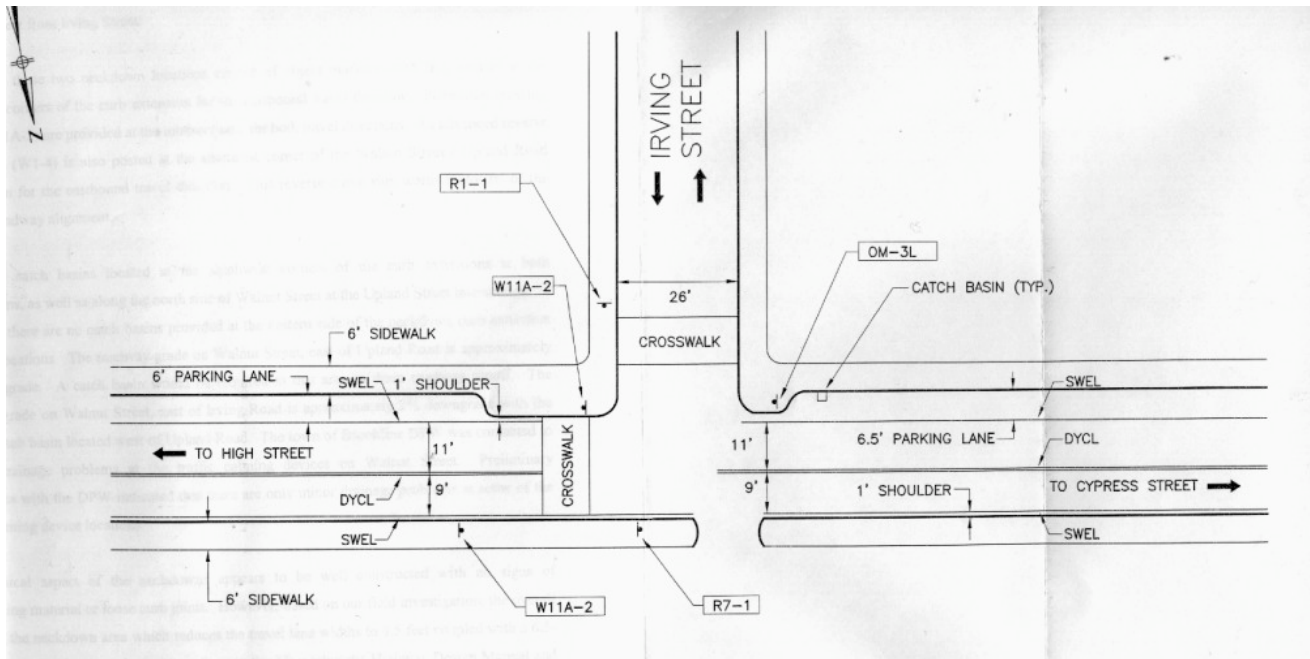
The neckdown at the southeast corner of the Irving Street intersection, as shown in Figure 3, is approximately five feet wide and thirty-one feet long while the southwest corner is approximately fourteen feet long and 4.5 feet wide. The neckdowns narrow the Walnut Street travel lane to approximately 9 feet and 11 feet for the westbound and eastbound travel directions, respectively. A one-foot shoulder is provided for westbound travel direction. The westbound 9-foot travel lane does not meet the Massachusetts Highway Design Standard and AASHTO minimum roadway width (10-foot) for a collector street. The sub-standard 9-foot travel lane is unsafe from an operational standpoint.

The pavement marking at both the intersections consist of the standard double yellow center line, single white edge line, parking lane line and crosswalk marking. The on-street parking lanes are provided along the southern side of Walnut Street in the vicinity of Upland Road and Irving Street. The 6.5-foot width on-street parking lane does not meet the 7-foot minimum requirement outlined in the Massachusetts Design Manual and AASHTO for collector streets. The narrow parking lane creates safety problems and will impede traffic flow along Walnut Street. At the Irving Street approach, vehicles are parked too close to Irving Street at the southwest corner of

the intersection on Walnut Street, thereby obstructing the sight distance for traffic entering onto Walnut Street from Irving Street.

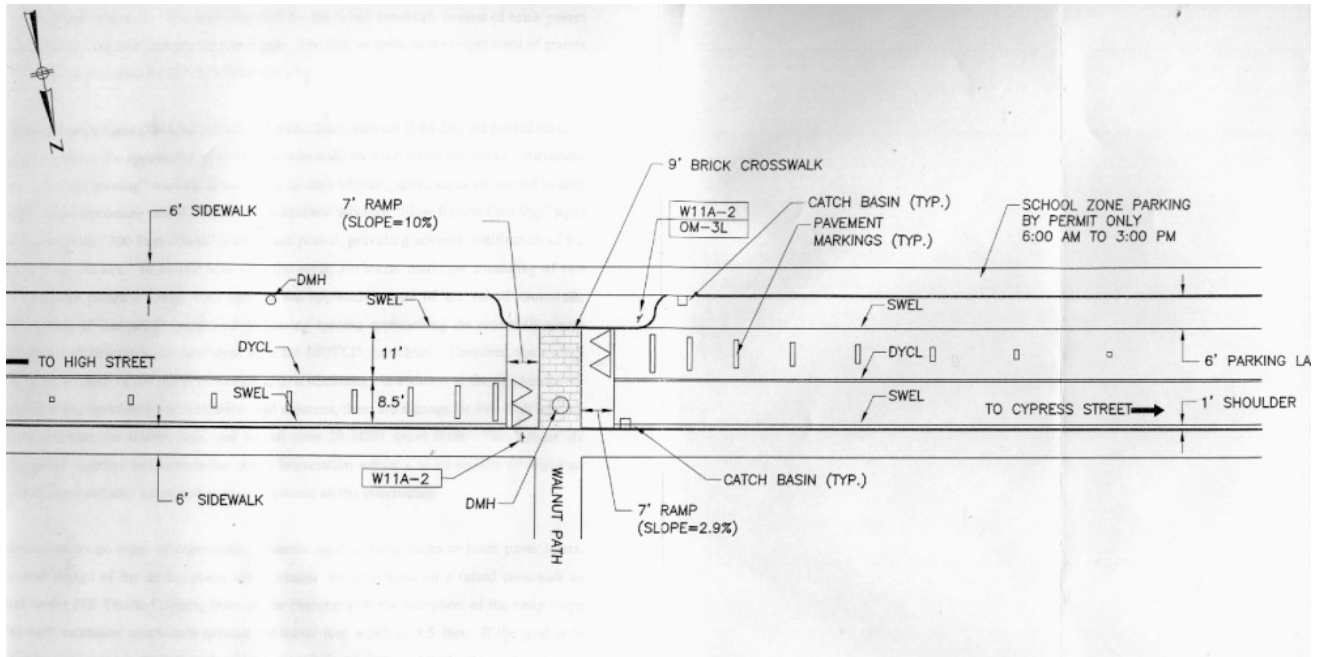
The crosswalk is approximately nine feet wide with seven-foot ramps. The height of the raised crosswalk is approximately six inches. Field measurements utilizing the Smart Level revealed that the ramp slopes are 10.0% for the east side and 2.9% for the west side.

The device shows no signs of deteriorating material such as loose curbs or brick paver joints. The overall design of the device meets the minimum design criteria for a raised crosswalk as outlined in the ITE Traffic Calming State of the Practice with the exception of the ramp slope and the curb extension area which reduces the travel lane width to 8.5 feet. If the goal is to reduce vehicular speed to 20 mph at the raised crosswalk, the 10% and 2.9% slopes do not meet the ITE design standard, which calls for 8% ramp slopes.

The 10% ramp slope exceeded the industry standard for raised crosswalk of 8% ramp slope for a 20 mph travel speed. The 10% slope will create safety problem for vehicle crossing the raised crosswalk and vehicle may air borne and bottom out as they depart from the device. The 2.9% slope will allow vehicles to cross the raised crosswalk at speeds greater than the 20 mph posted advisory speed. In addition, the transition between the existing roadway and the crosswalk ramps

is abrupt due to poor vertical transition from the roadway to the crosswalk ramps. This poor vertical transition and the substandard slopes accounts for the pavement injury that exists in the area departing the raised crosswalk from both the travel directions.

Pavement damage exists on the departing side of the raised crosswalk in both travel directions. The scraped pavement indicates that vehicles are traveling at high speeds crossing the raised crosswalk and bottoming out as they depart from the device. The speeding at this raised crosswalk is a result of the steep ramp slope (10%) and the wide spacing between the traffic calming devices, which provides vehicles an opportunity to increase speed between the devices.

- Restrip travel lane and parking lane widths to provide a 7 foot parking lane and 10 foot travel lane to conform with AASHTO and MassHighway design standards for travel lane and parking widths for collector roads.
- Improve raised crosswalk ramp slopes to meet industry standards for a 20 MPH design speed, which calls for an 8% slope.
- Install catch basins east of the raised crosswalk to prevent ponding of water at the ramp at the eastern edge of the crosswalk.
- Replace the existing pedestrian crossing sign (W11A-2) with "Raised Crossing" sign.
- Removed advance signage for raised crosswalk. Also, see signage improvements section.

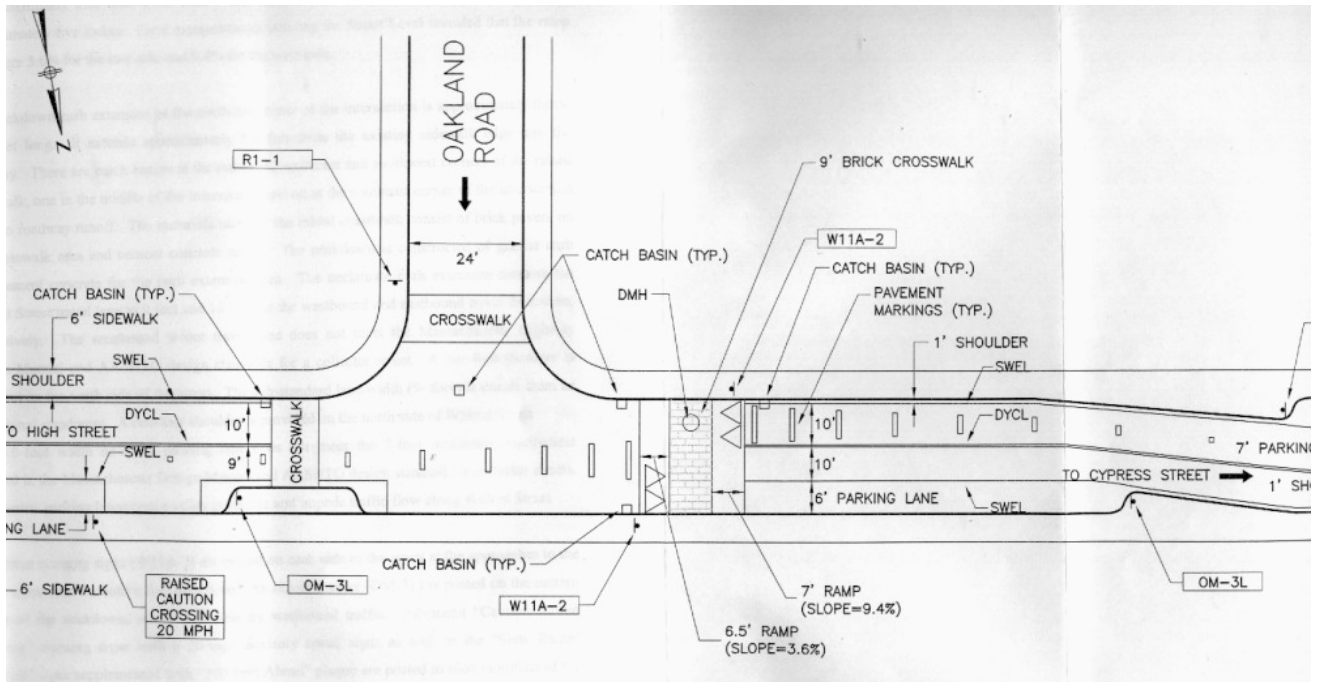
The raised crosswalk is located across the western Walnut Street leg of the intersection, while the neckdown is located at the northeast corner of the intersection (see Figure No. 5). The crosswalk

is approximately nine feet wide with 7-foot ramps. The height of the raised crosswalk is approximately five inches. Field measurements utilizing the Smart Level revealed that the ramp slopes are 3.6% for the east side and 9.4% for the west side.

The neckdown curb extension at the northeast corner of the intersection is approximately thirty-two feet long. It extends approximately 5.5 feet from the existing sidewalk edge into the roadway. There are catch basins at the northeast, southeast and southwest corners of the raised crosswalk, one in the middle of the intersection and one at the southeast corner of the intersection to drain roadway runoff. The materials used for the raised crosswalk consist of brick pavers on the crosswalk area and cement concrete ramps. The neckdown is constructed of granite curb with cement concrete for the curb extension area. The neckdown curb extension narrows the Walnut Street travel lane to 9 feet and 10 feet for the westbound and eastbound travel directions, respectively. The westbound 9-foot travel lane does not meet the Massachusetts Highway Design Manual and AASHTO design standards for a collector street. A one-foot shoulder is provided on the north side of the street. The sub-standard lane width (9-foot) is unsafe from an operational standpoint. A one-foot shoulder is provided on the north side of Walnut Street. The 6.0-foot width on-street parking lane does not meet the 7-foot minimum requirement outlined in the Massachusetts Design Manual and AASHTO design standard for collector streets. The narrow parking lanes create safety problems and impede traffic flow along Walnut Street.

The west side of the ramp slope (9.4%) exceeds the industry standard for raised crosswalk which

is 8% for a 20 mph travel speed. However, the east side of the slope (3.6%) is less than 8%, which allows vehicles to cross the raised crosswalk at speeds greater than the 20 mph posted advisory speed. The substandard slope accounts for the pavement injury that exists in the area departing the raised crosswalk from both the travel directions. The scraped pavement indicates that vehicles are traveling at high speeds exceeding the posted 20 mph advisory speed when crossing the raised crosswalk and bottoming out as they depart from the device. The speeding at the raised crosswalk is also due to the wide spacing between the two raised crosswalks.

- Restrip travel lane and parking lane widths to provide a 7 foot parking lane and 10 foot travel lane to conform with AASHTO and MassHighway design standards for travel lane and parking widths for collector roads.
- Reconstruct raised crosswalk ramp slopes to meet industry standards for a 20 MPH design speed, which calls for an 8% slope.
- Replace the existing pedestrian crossing sign (W11A-2) with "Raised Crossing" sign.
- Removed advance signage for raised crosswalk. Also, see signage improvements section.

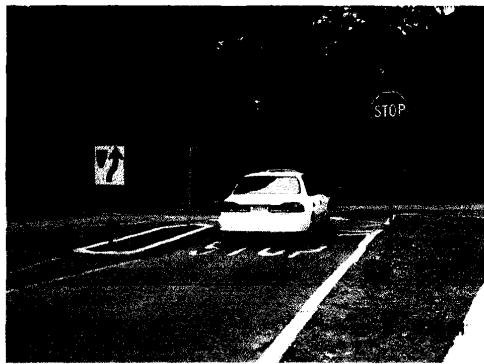
Figure 6

approaching the intersection. The raised median is approximately twenty feet long and four feet wide and is constructed of granite curbing and asphalt. A crosswalk is painted across the westbound approach lane of the intersection. This T-intersection is a two-way, stop-controlled intersection with eastbound and northbound approaches controlled by Stop signs (R1-1). The raised median is shown in Figure 6.

**Raised Median/Island Treatment and Curb Extension at  
Walnut Street / Warren Street Intersection (eastern side)**

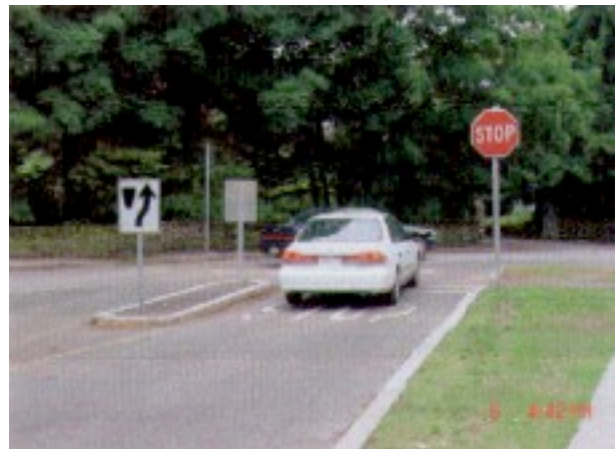
The Walnut Street westbound approach to Warren Street at the northwestern point of the delta island is also under Stop control. Pedestrian sign (W11-2) are visible by motorists traveling westbound along Walnut Street, as well as along the Warren Street southbound and northbound approaches. These two points of the intersection (east and southwest of the delta island) also have painted crosswalks. At the raised median, keep right signs (R4-7), are visible by motorists approaching from both the northbound and southbound directions. Along Warren Street between the two legs of Walnut Street, a "Slow" warning sign is posted for southbound traveling vehicles. Additional roadway alignment signs (W1-10) are posted along Warren Street warning drivers of upcoming curves and intersections. The Warren Street roadway alignment consists of a 4 to 5% downgrade from the south. The Walnut Street vertical alignment within the triangular intersection is approximately 3% downgrade from the west and southwest directions. The eastern sections of Walnut Street have an approximate 3 to 7% downgrade in the eastbound direction

The overall construction of the Median/Island Treatment and Curb Extension is well constructed with no signs of deteriorating material or loose curb joints. Similarly, the overall design of the device meets the minimum design criteria for a curb extension and median/island treatment.

Although the southwestern portion of the triangular intersection is evaluated to be satisfactory from a traffic calming standpoint, we recommend continued monitoring of the overall triangular intersection locations for traffic safety operations.
